BUREAU OF SHIPS GROUP
TECHNICAL INSPECTION REPORT

OPERATION CROSSROADS.
U.S.S. CRITTENDEN (APA 77).

TEST BAKER [U].

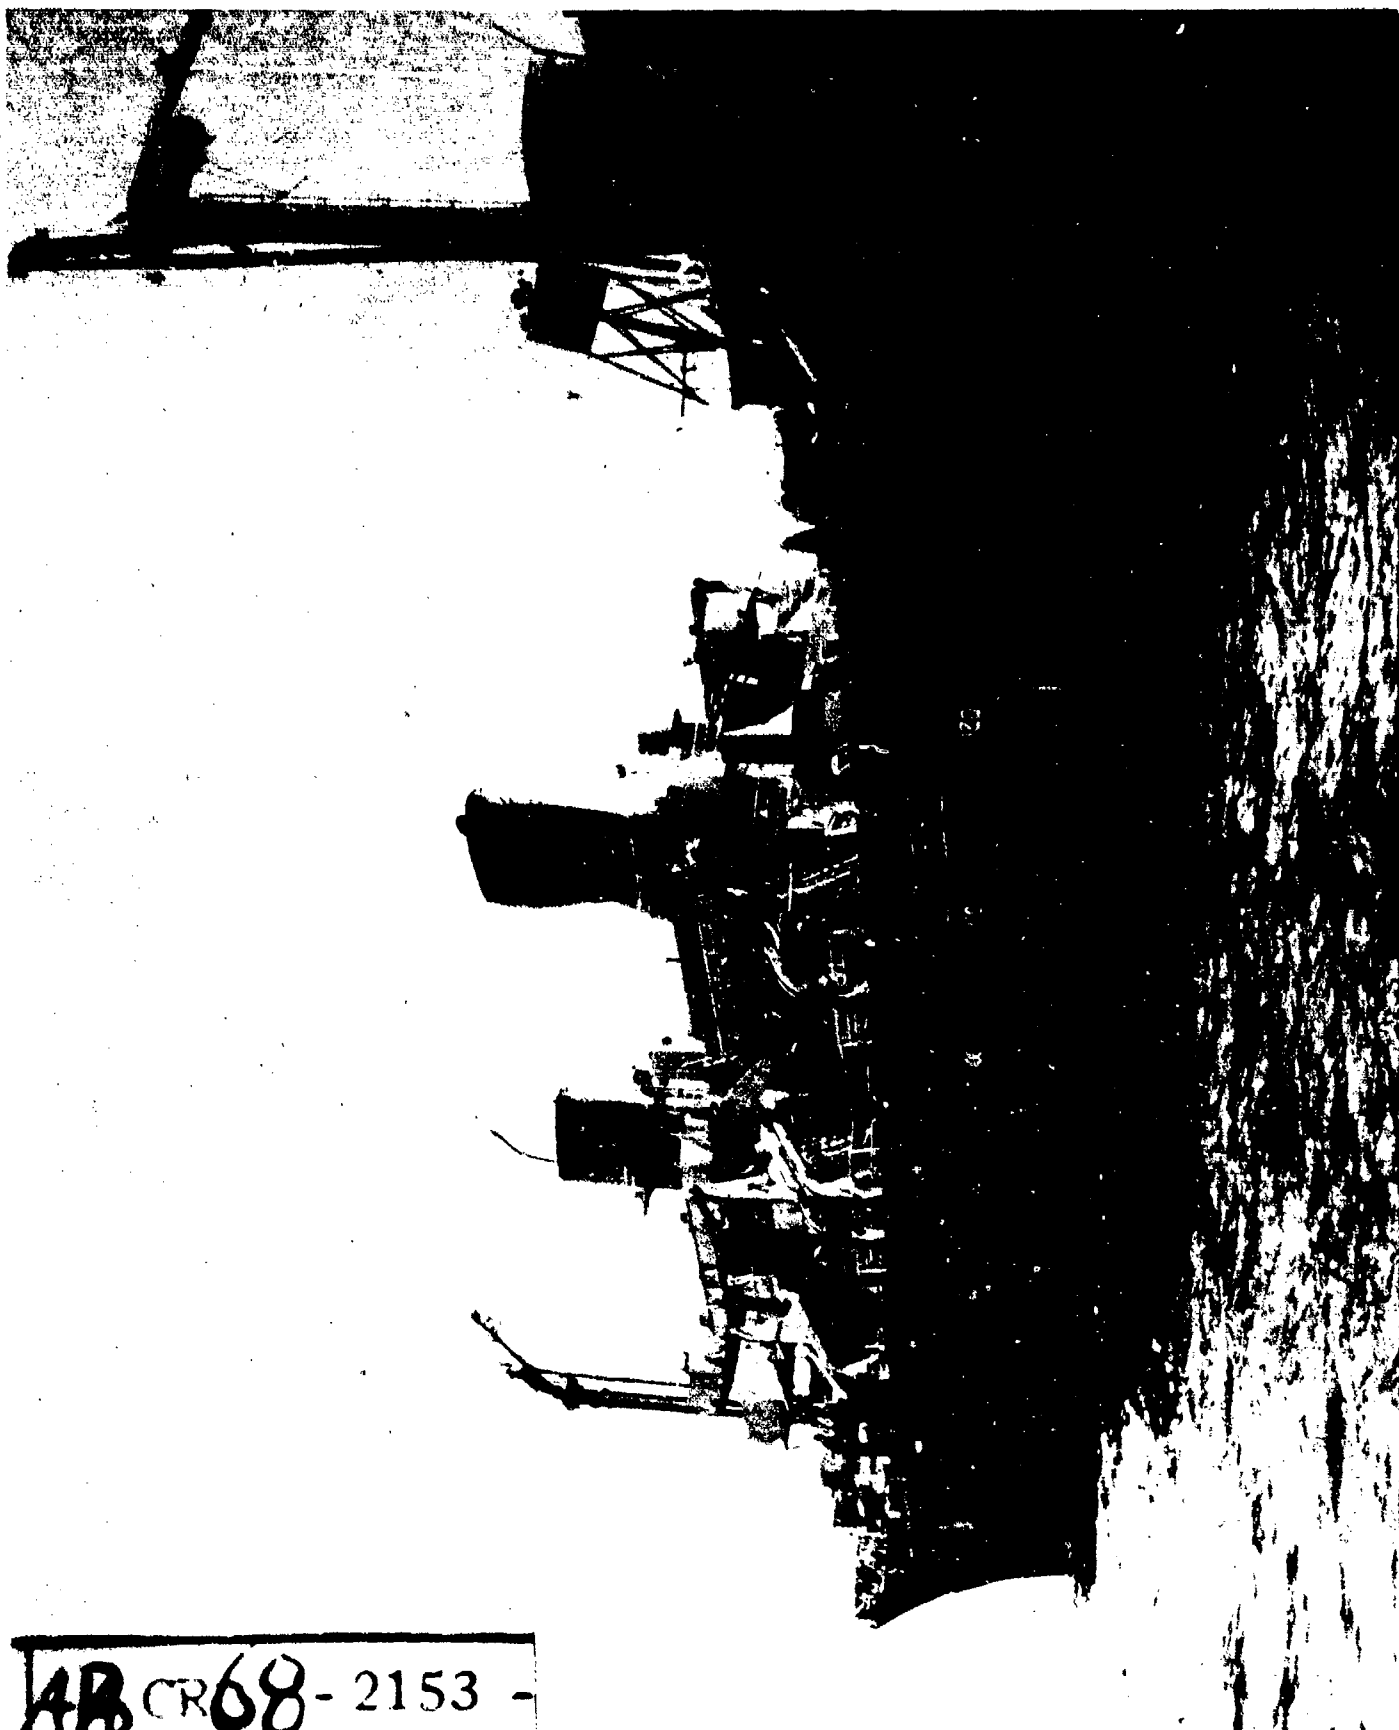
Guns and directors are not affected. The previously dislocated 40MM director foundation on the after deckhouse top, port, shows no additional displacement (photo 2153-10, page).

AB-CR-68-2153-10. View from off port quarter, bow to frame 142.
